Roof Name: Upper Flat Roof
Roof Size: 49,140 sq. ft.
Est. Replacement Cost: \$196,560
Existing System Type: Ballasted EPDM
Year Installed: 1985 (Estimated)
Height: 30 feet
Slope: Slight
Interior Sensitivity: Normal
Drainage: Adequate
Currently Leaking? Unknown
History of Leaking? Yes

Overall Roof Inspection Assessments

Date	Inspection Type	Inspecting Company	Inspector Name
Sep, 2005	Visual Inspection	Dry-Tech Commercial Roofing Services, Inc.	Mark Krider

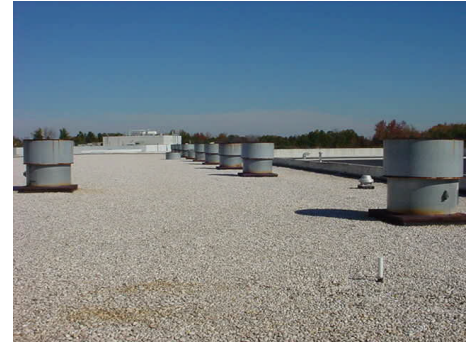
Drainage and Leak Details: The roof appeared to have adequate drainage toward the roof drains and no ponding water was noticed at the time of this inspection. It has been reported that leaks occur along the walls in the past. The current extent and location of "active" roof leaks was not known at the time of this inspection.
