# *Roof Inspection Report*

**Facility:** Sample Building One  
123 Sample Rd.

Roof: Roof A

Building: Building #4

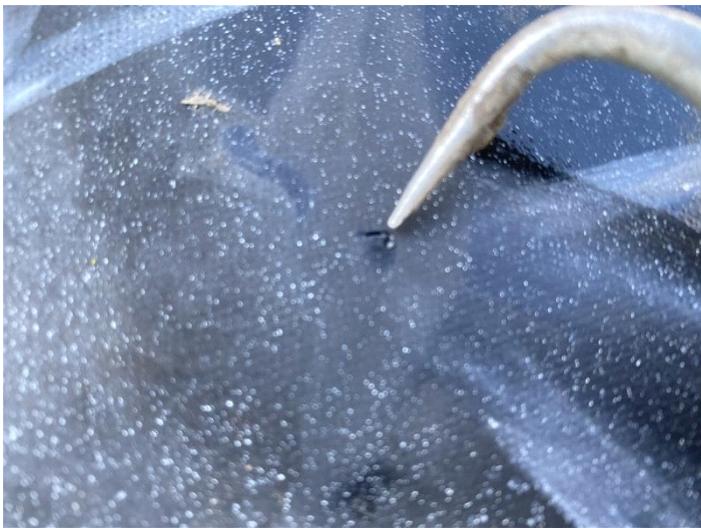
## Hole

Small hole found in membrane.

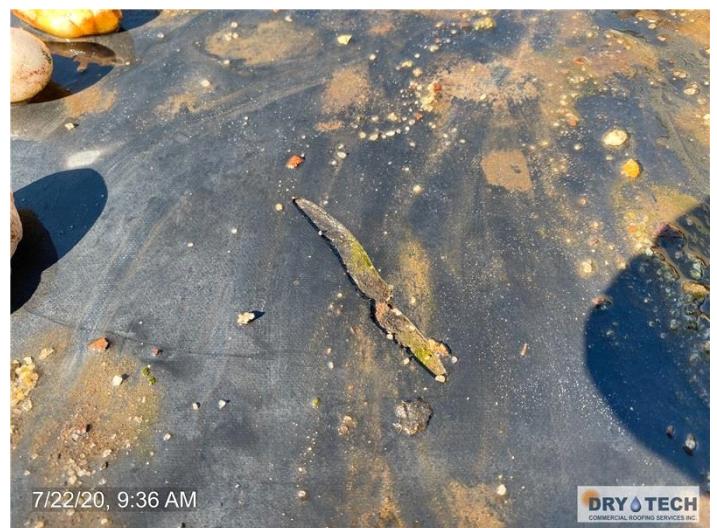
## Hole

Large hole/split found in membrane.

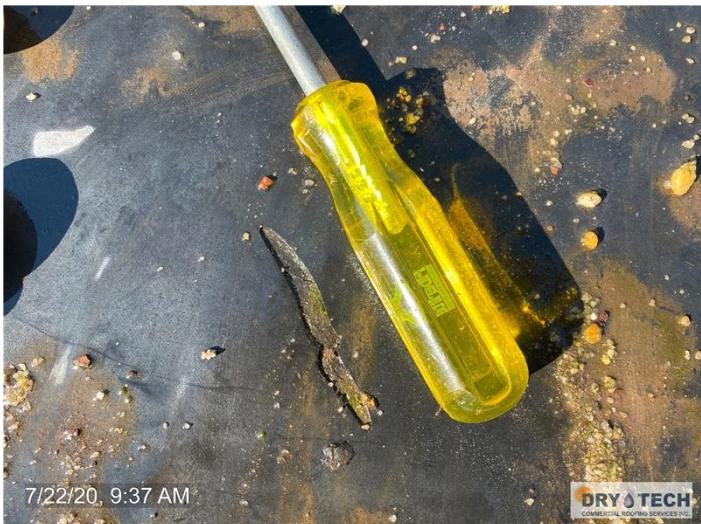
## Hole

Large hole/split found in membrane.

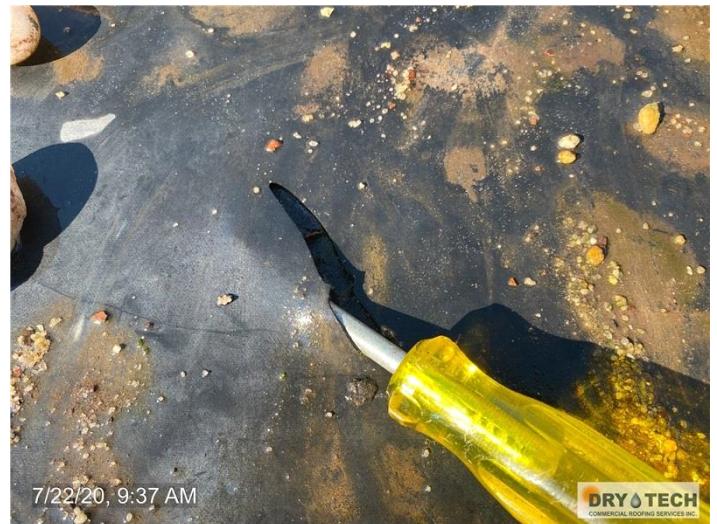
## Hole

Large hole/split found in membrane.

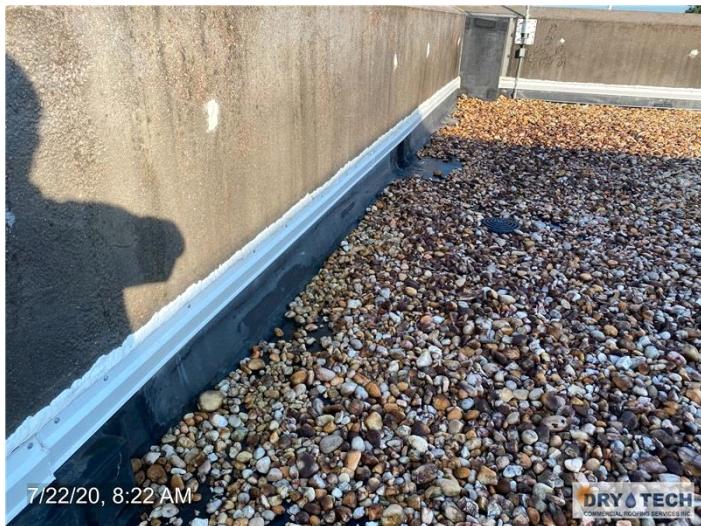
## Minor Bridging

Minor bridging occurring at wall flashings. If conditions worsen. flashings should be replaced.

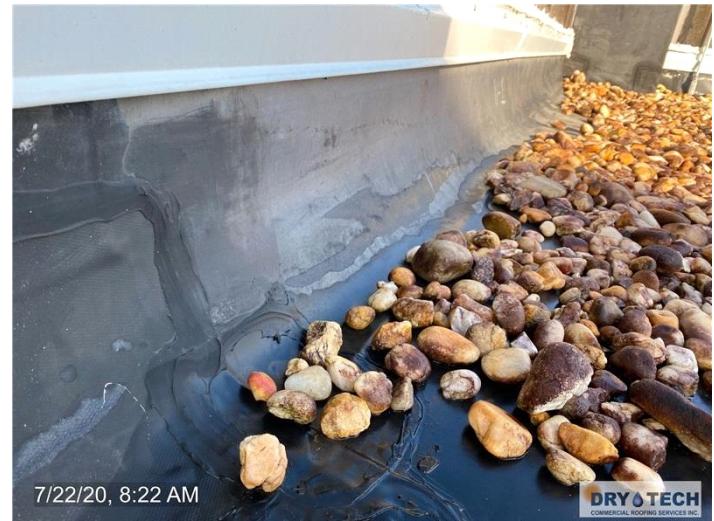
## Minor Bridging

Minor bridging occurring at wall flashings. If conditions worsen. flashings should be replaced.

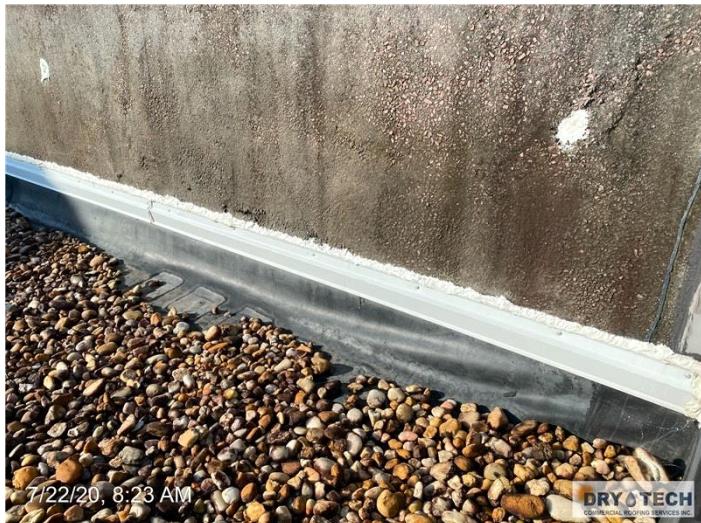
## Minor Bridging

Minor bridging occurring at wall flashings. If conditions worsen. flashings should be replaced.

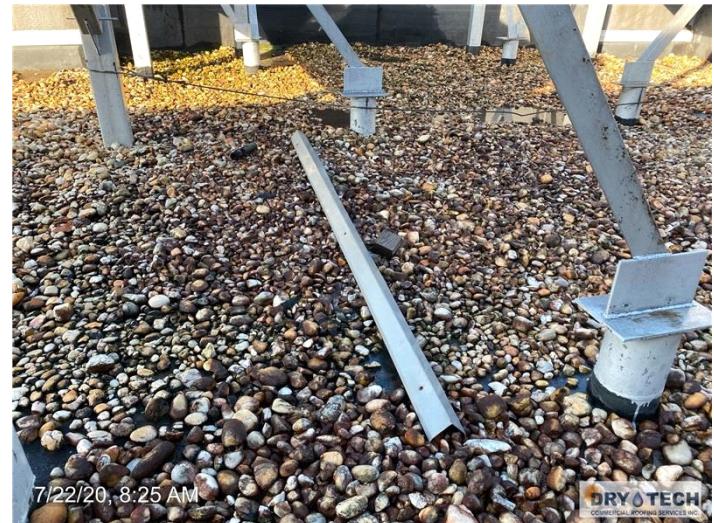
## Debris/Equipment

Equipment with sharp edges can puncture the membrane and should be removed.
