# *Roof Inspection Report*

**Facility:** Sample Building One  
123 Sample Rd.

Roof: Roof A

Building: Building #4

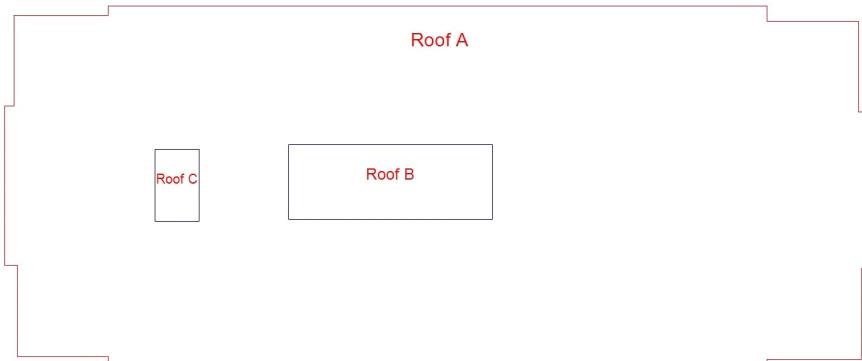
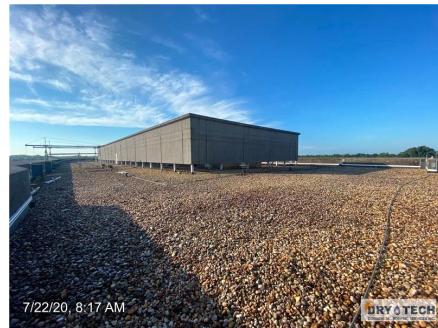
Roof System: Main  
Roof Deck: Metal  
Roof SF: 29,766

**Condition Assessment:** 3 - Fair

This roof is in fair condition for its age. This is the original roof of the building, which was completed in 1999 (21 years). Leaks were reported near the mechanical room penthouse walls. A large hole was found in the EPDM membrane near the penthouse and cooling tower. In the same area, a pitch pocket was found that was improperly installed. The pitch pocket was never flashed and was relying on the pourable sealer to hold it into place. The pitch pocket is obsolete and should be removed or replaced. The walls of the penthouse may be a large contributor of the leak issue. It was reported that the leak occurs during heavy and wind-driven rain events. The EIFS wall system around the penthouse was made as a drainage system, with a through-wall counter flashing. The counter flashing is the exit point for any moisture or water that accumulated within the wall system. With the counter-flashing sealed, there is nowhere for water to escape until it goes up and over the back flange of the counter flashing metal, and into the interior of building. A water test of the roof and the wall system will aid in identifying the leak. A proper water test includes working from the bottom up, spraying the lower main roof, the wall system, and the upper roof in increments of 1-2 hours until leak is sourced. Once the source is identified, we will make temporary repairs and begin to spray the water again. If the leak is resolved, permanent repairs will be made as needed.
